Generic 8D REPORT

Power Module LMZ12xxx & LMZ14xxx

07/11/2014 - Rev. B

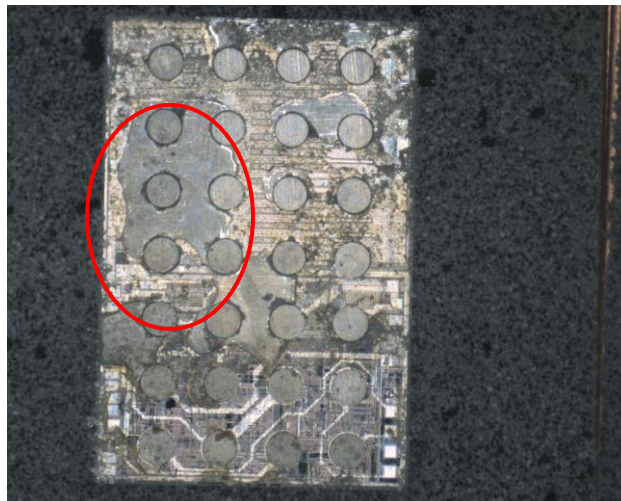
TI has verified that some devices may exhibit solder extrusion causing failures during inline testing after SMT. When solder extrusion bridges the neighboring bump (or die edge), it will result in electrical failure. Below is the picture of the observed solder extrusion after parallel lapping.

Solder extrusion requires a molten solder and a path for the solder to extrude into. The path is created by a delamination between the mold compound and the die.

TI implemented 1st Test ==> 1X Reflow @245C ==> 2nd Test to screen out marginal units (May 2012).

Improvement Actions	Owner	Date
1. Optimize de-flux process: The process to clean off the flux residue after bump operation on the flip chip die was optimized to ensure no flux residue is left behind.	A/T Site	Completed: Feb 2012

2. Bake after de-flux: To further ensure that any remaining flux residue is inactivated; a bake process using a dedicated oven was implemented.	A/T Site	Completed: March 2012

3. Batch Plasma operation before mold: The weakness at the interface of the mold compound and the flip chip die surface provide a path for the solder to extrude during reflow. The plasma process roughens the die surface enabling better adhesion of the mold compound with this surface.	A/T Site	Completed: August 2012

5. TI has introduced an improved plasma process (Strip Plasma). This process provides improved roughening quality and homogeneous cleaning for the die surface which helps in better	A/T Site	Completed: April 2013

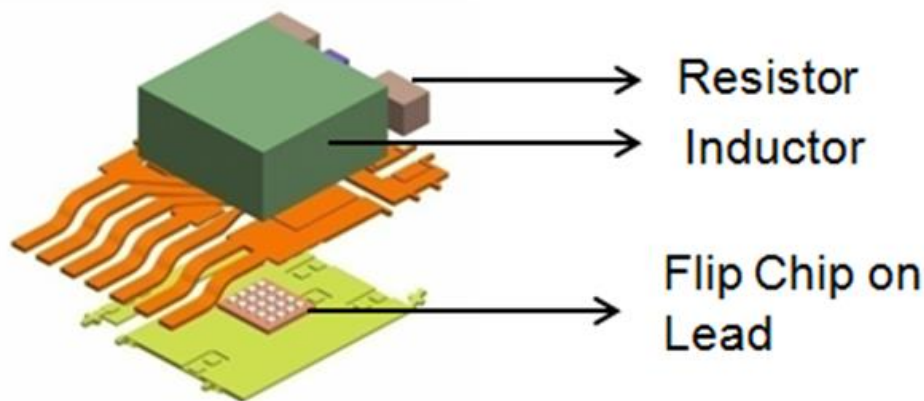
The power module family of devices from Texas Instruments (TI) undergoes a complex assembly process which involves passive components (inductor, resistors) along with a flip chip on lead bare die packaged together.

TI has verified that some devices from lots may exhibit solder extrusion causing failures during inline testing after SMT. When solder extrusion bridges the neighboring bump (or die edge), it will result in electrical failure.

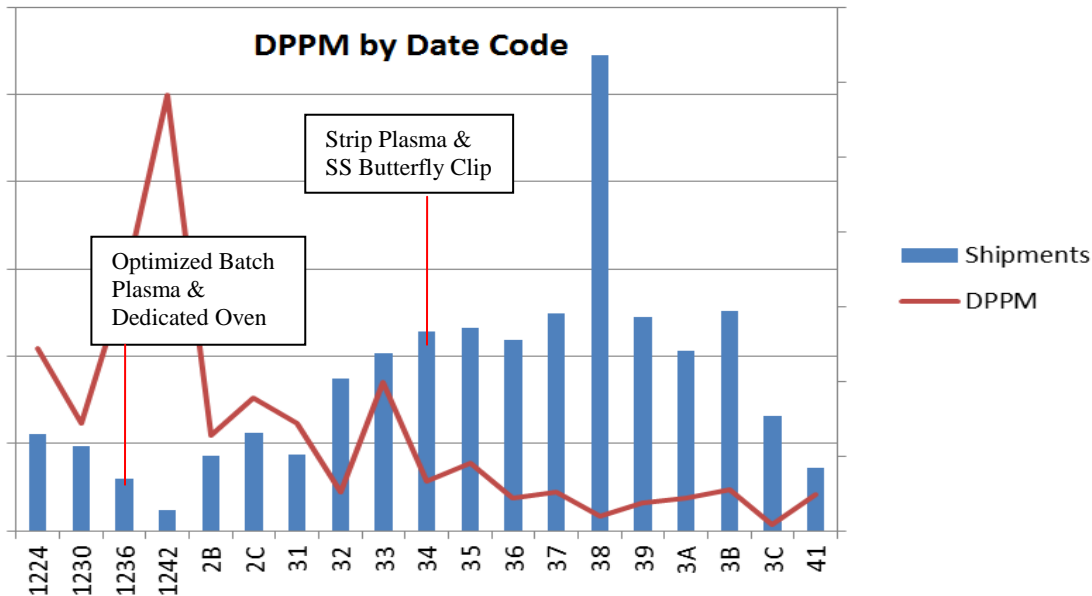
The data was collected by data mining the shipment info and customer returns as of July 2014. The graph shows the high DPPM rate in 2012. The shipments significantly increased in 2013 while the DPPM rate has significantly reduced.

TI attribute this to continuous improvements implemented in TIEM (latest ones being Strip Plasma & Stainless Steel butterfly jig) to make this package family more robust
