Understanding **MP6500** Current Control

Application Note

Prepared by Pete Millett

April 2017

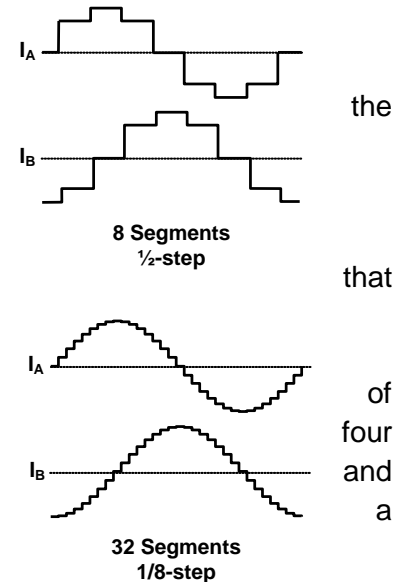
Usually, steppers are not driven with analog linear amplifiers – they are driven using a PWM current-regulating driver with discrete current values break the sine wave into straight segments (see Figure 1). This is called microstepping. The sine wave may be broken up into any number of segments, and the waveform approaches a true sine wave as the number of segments increases. In practice, the number of segments varies from to 2048 or more, with most IC stepper drivers implementing between four 64 segments. Since one sine wave generates four mechanical states in stepper motor called steps, a 32-segment sequence is called a 1/8-step operation.

Figure 1: Stepper Motor Current Waveforms

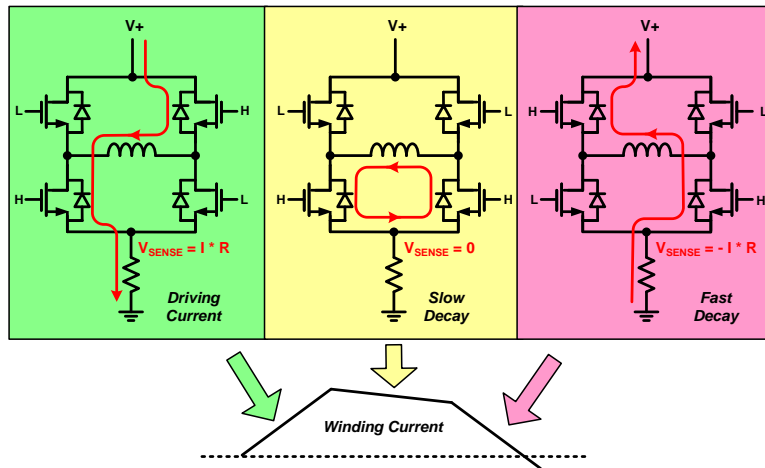
After the desired peak current is reached, the H-bridge can drive the winding current down in one of two ways. One, if the winding is short-circuited (by turning on both low-side or both high-side MOSFETs), the current decays slowly. Two, if the H-bridge is reversed or if the current is allowed to recirculate through the MOSFET body diodes, the current decays quickly. These two options are called slow decay and fast decay (see Figure 2).

Figure 2: Decay Modes

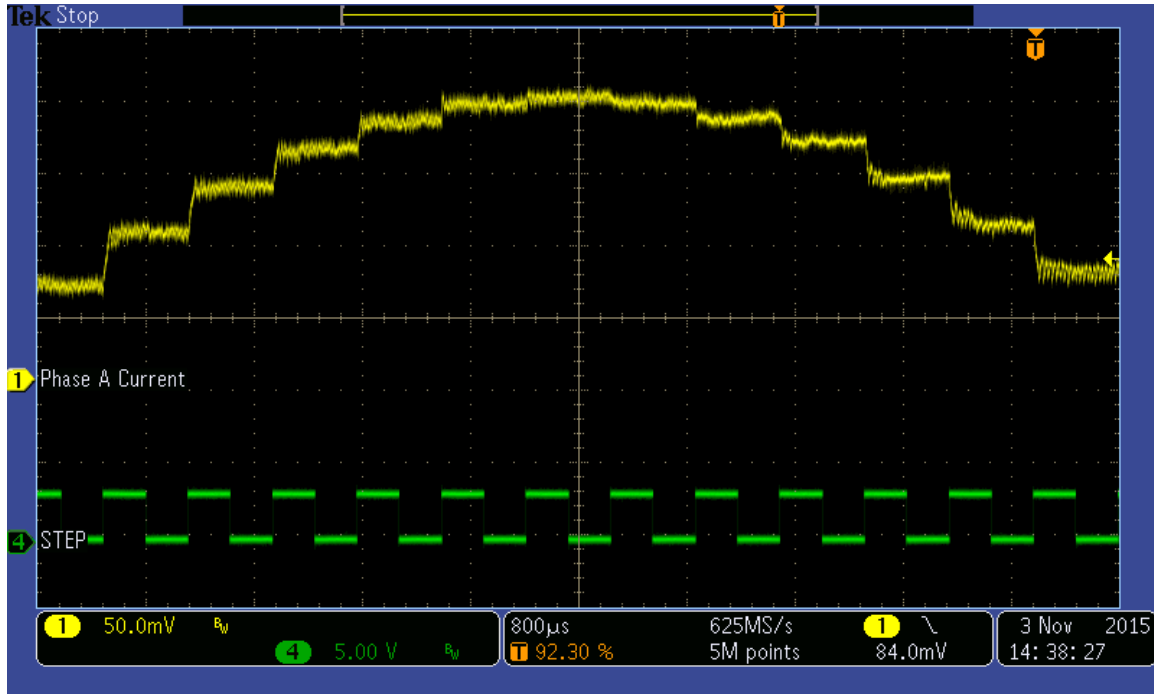
Using this current regulation method, the MP6500 regulates the average winding current quite accurately throughout the entire waveform (see Figure 8). This improved current control results in measurable improvements to motion quality.

Figure 8: MP6500 Current Regulation Waveform

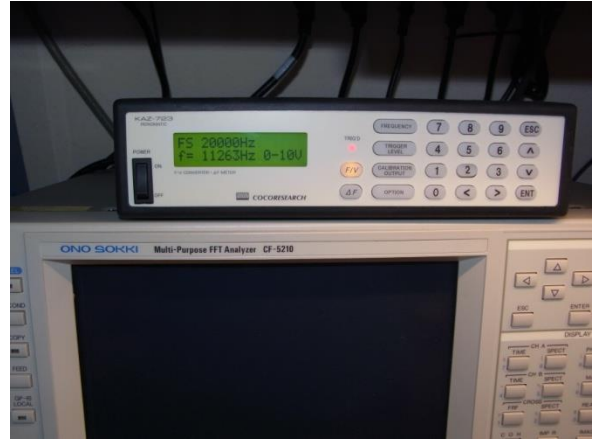
To make measurements of the motion, a frequency-to-voltage converter (Coco Research KAZ-723) was used to process the output of the optical encoder with its output observed on an oscilloscope and FFT analyzer. This output is a voltage that is representative of the motor speed updated at a very high rate.

Figure 10: KAZ-723 F/V Converter

This setup is shown in Figure 9 and Figure 10.

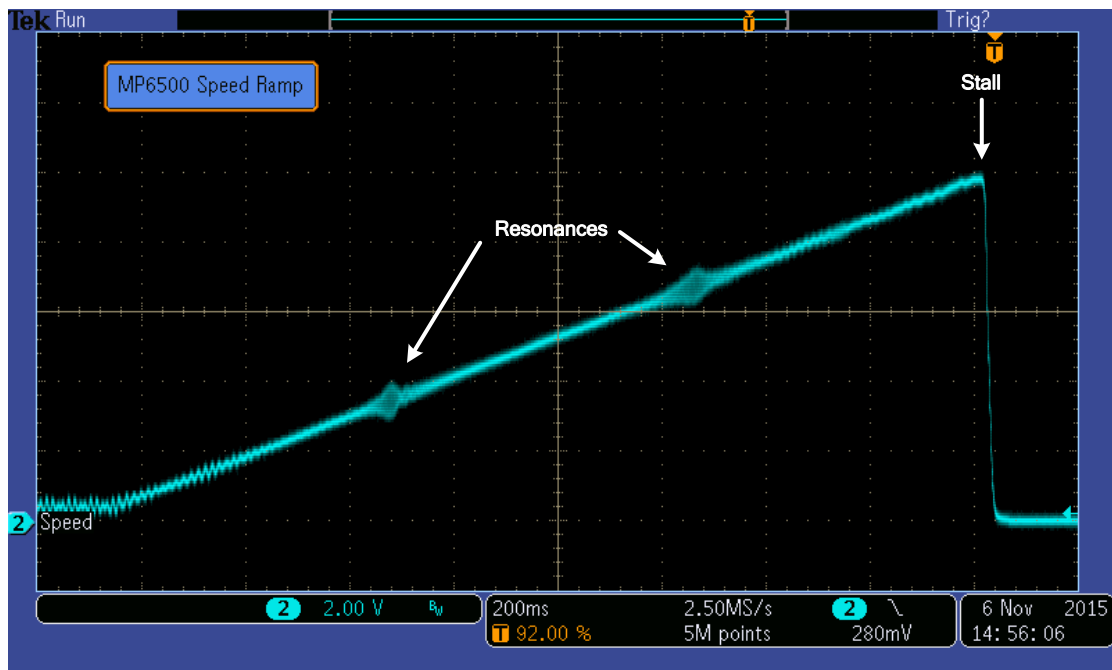
Using the same setup and winding current, the MP6500 shows the ability to drive to a significantly higher speed (see Figure 15). A stall occurs at a measurement voltage of about 10V, which corresponds to around 600RPM. This is due to improved current regulation at high step rates.

Figure 15: MP6500 Speed Ramp
